SITE ASSESSMENT REPORT
FOR
METRO PLATING SITE
DETROIT, WAYNE COUNTY, MICHIGAN
TDD 805-9704-014
PAN 7A1401SIXX

June 1, 1997

UNITED STATES ENVIRONMENTAL PROTECTION AGENCY
Emergency Response Branch
77 West Jackson Boulevard
Chicago, Illinois 60604

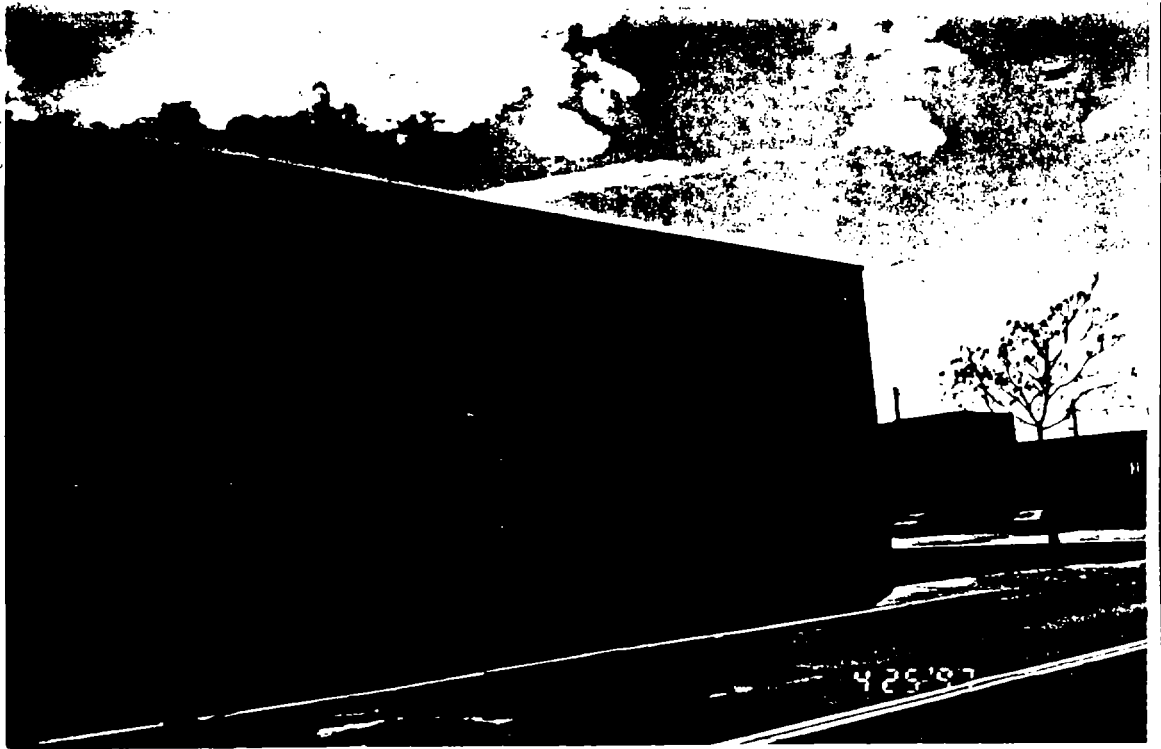
Site: Metro Plating
Photo No: 1 (R1F12)
Direction: Southwest
Camera: Olympus Infinity 35mm
Photographer: C. Gibson

Date: April 25, 1997
Subject: North side of Metro Plating.

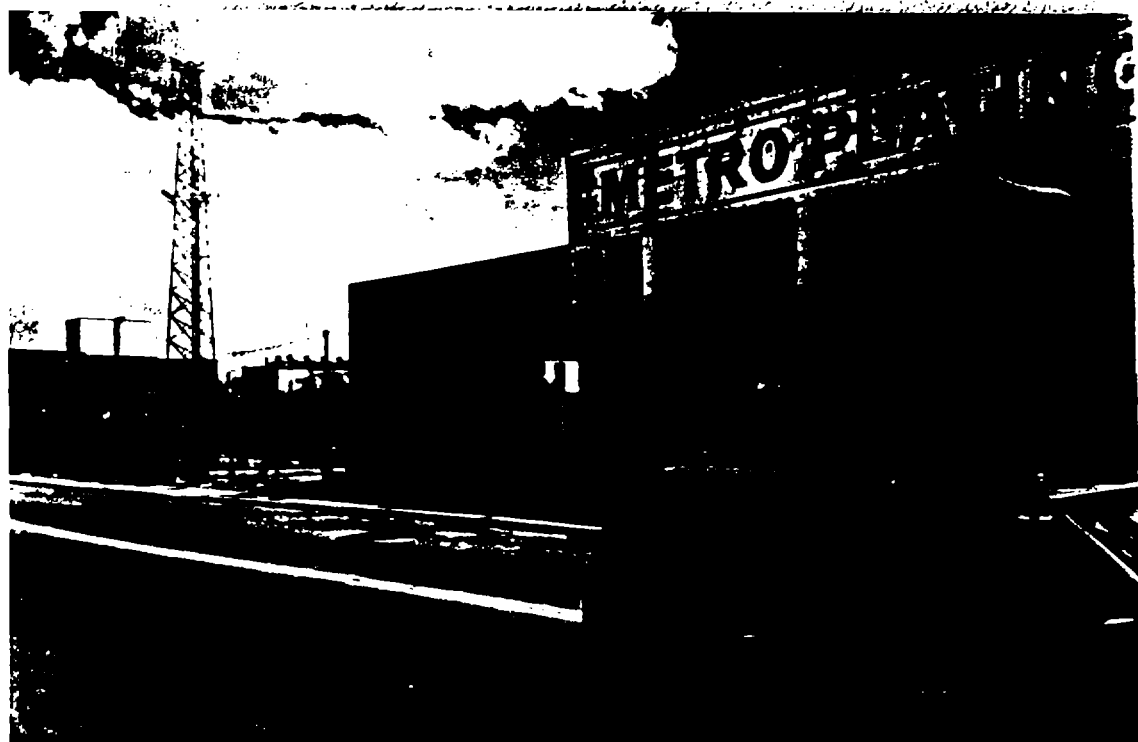
Site: Metro Plating
Photo No: 2 (R1F13)
Direction: Southeast
Camera: Olympus Infinity 35mm
Photographer: C. Gibson

Date: April 25, 1997
Subject: Metro Plating, including a new portion on the east side.

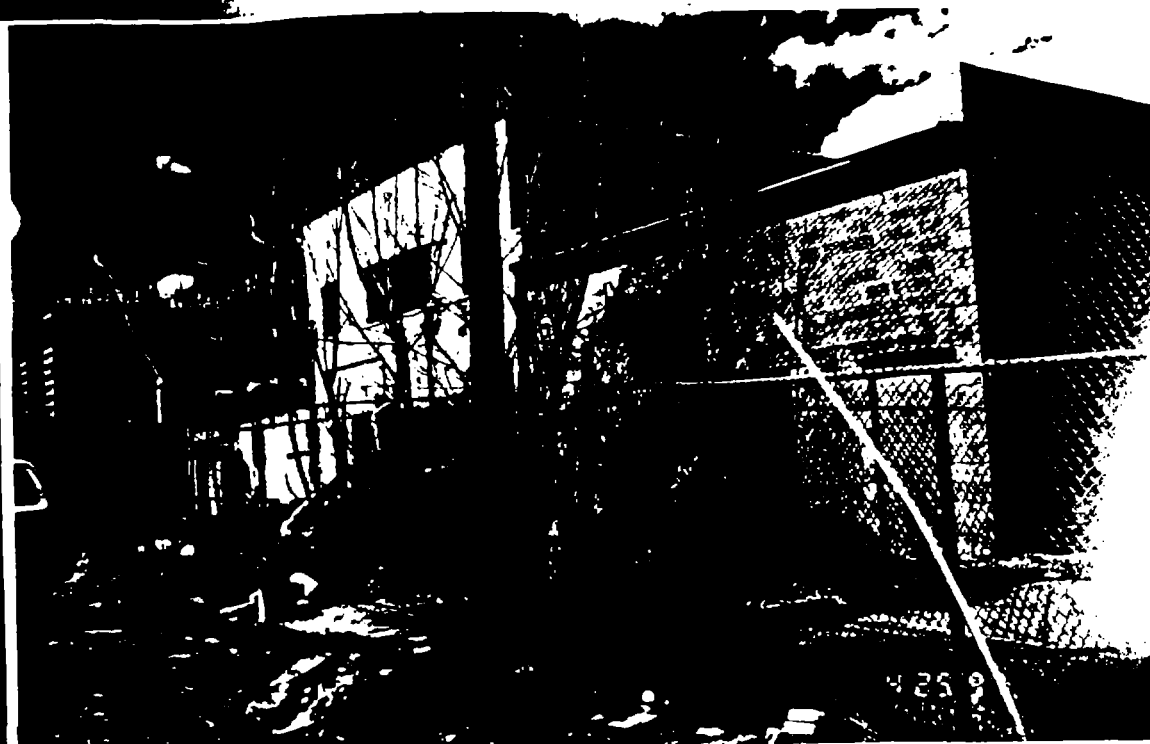
Site: Metro Plating
Photo No: 4 (R1F9)
Direction: Northwest
Camera: Olympus Infinity 35mm
Photographer: E. Edlinger

Date: April 25, 1997
Subject: The south side of the Metro Plating building. Note the General Motors and Fisher Buildings in the background.

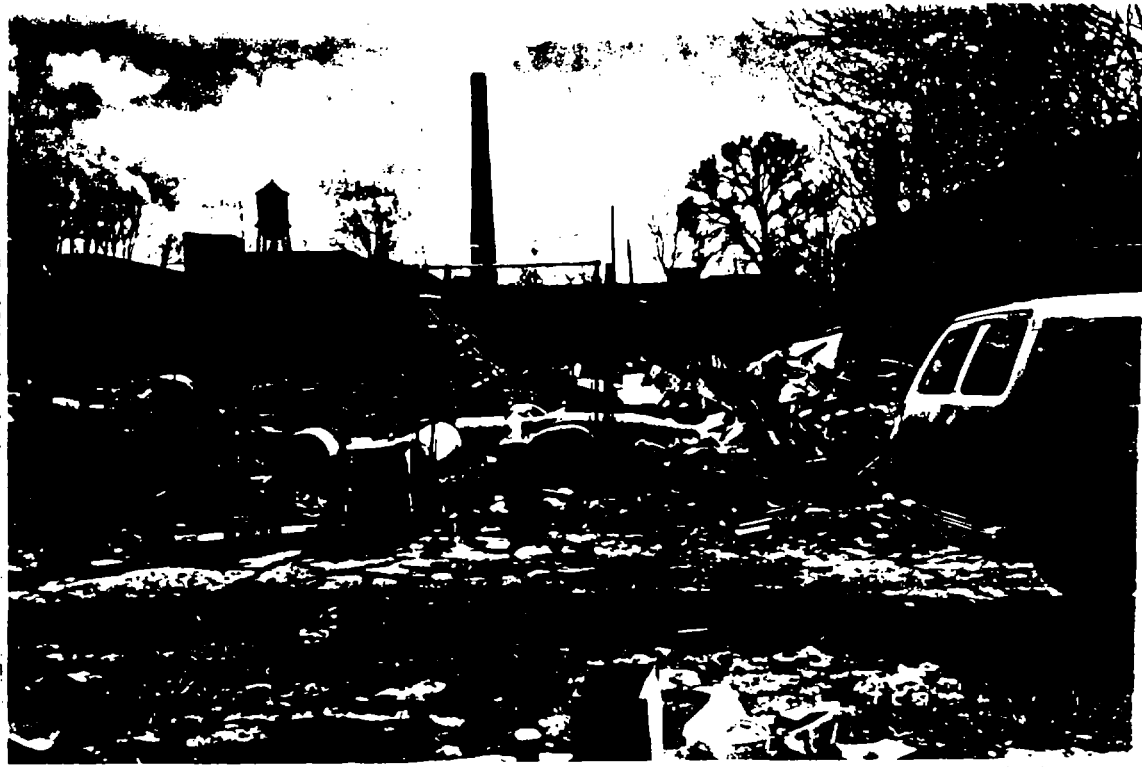
Site: Metro Plating
Photo No: 5 (R1F8)
Direction: North
Camera: Olympus Infinity 35mm
Photographer: E. Edlinger

Date: April 25, 1997
Subject: A fenced lot
 cluttered with debris, south
 of Metro Plating.

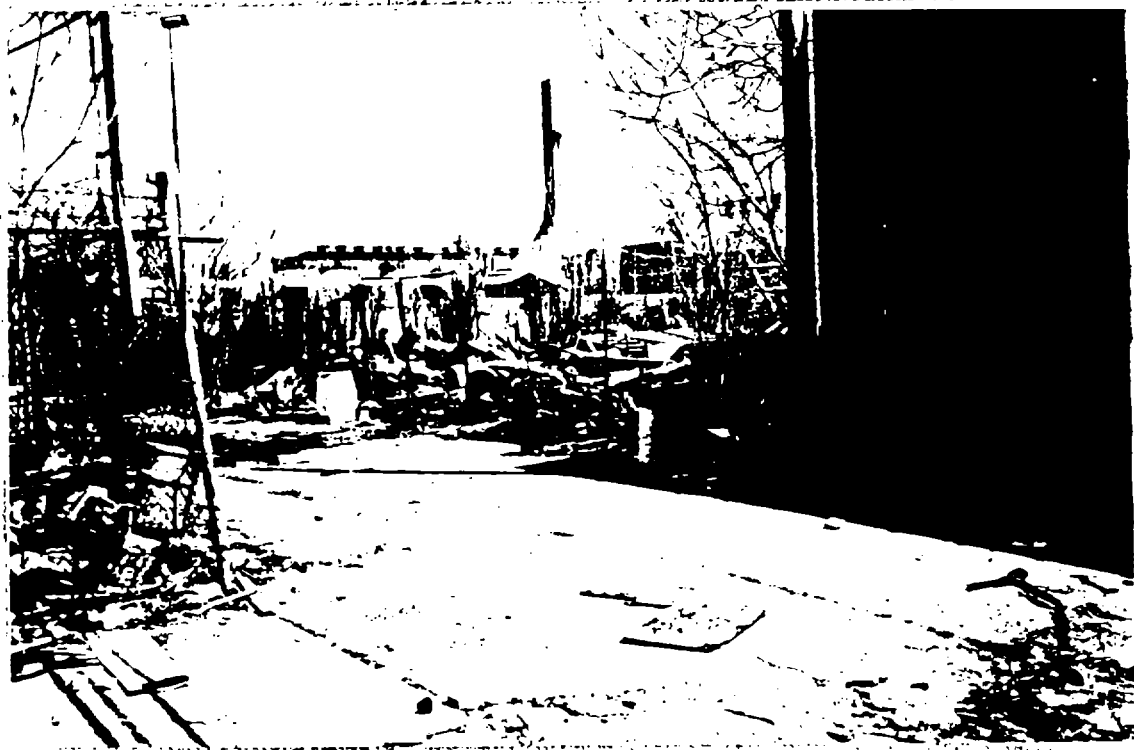
Site: Metro Plating
Photo No: 6 (R1F17)
Direction: Southeast
Camera: Olympus Infinity 35mm
Photographer: E. Edlinger

START continued waste inventory and characterization activities outside of the building. START located several drums scattered outside the building. There were approximately six drums in an unsecured, fenced area, attached to the south side of the building. A mound of soil was observed in another fenced area south of the alley and MP. The fenced area was inaccessible and contained additional drums and vats.

Date: April 25, 1997
Subject: The alley and fenced
 lot south of Metro Plating.

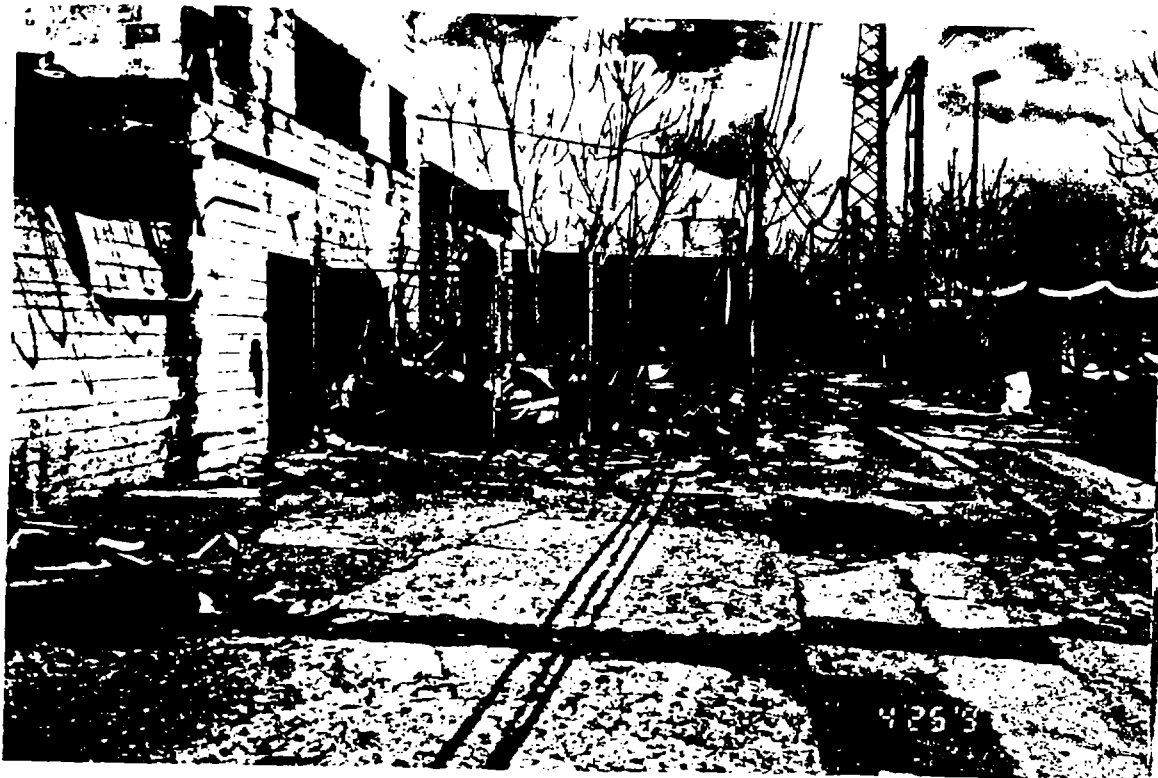
Site: Metro Plating
Photo No: 7 (R1F15)
Direction: East
Camera: Olympus Infinity 35mm
Photographer: C. Gibson

Date: April 25, 1997
Subject: The unsecured, fenced storage area south of the building.

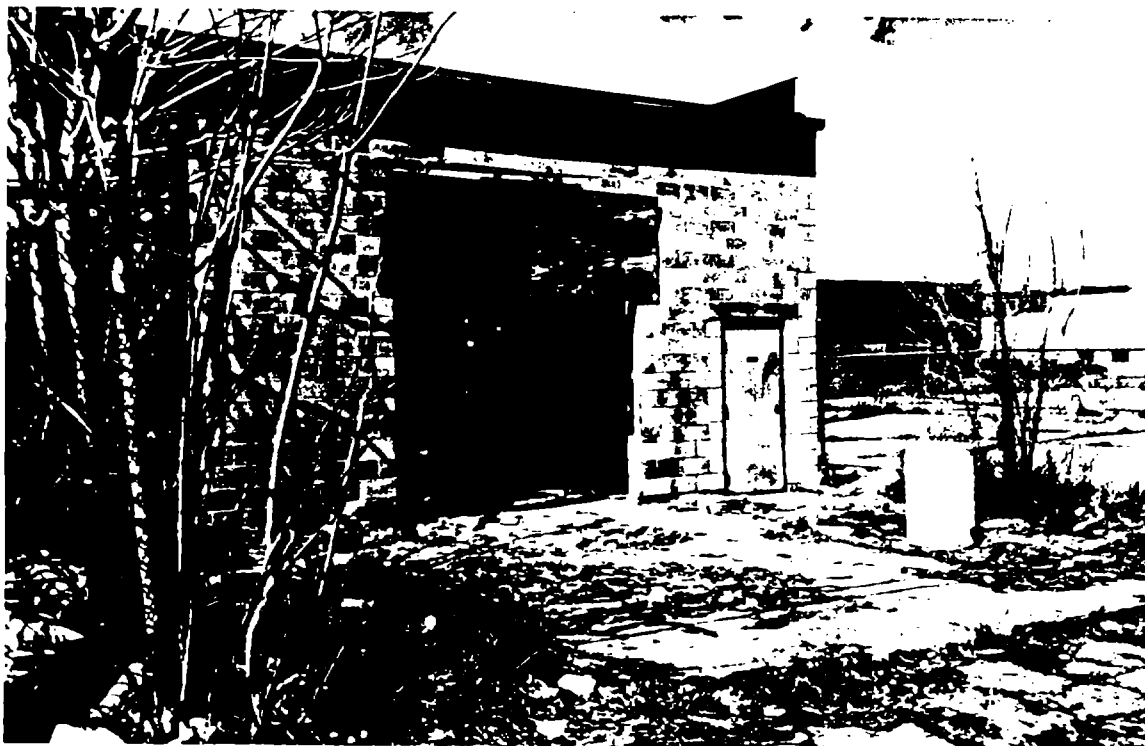
Site: Metro Plating
Photo No: 8 (R1F16)
Direction: East
Camera: Olympus Infinity 35mm
Photographer: C. Gibson

The main entrances to the building have been secured by the City of Detroit with plywood; however, the plywood has been removed by trespassers and vandals. This ease of access provides ample opportunity for exposure to hazardous materials by both humans and

Date: April 25, 1997
Subject: An access route trespassers or vandals have used to enter the south side of the building.

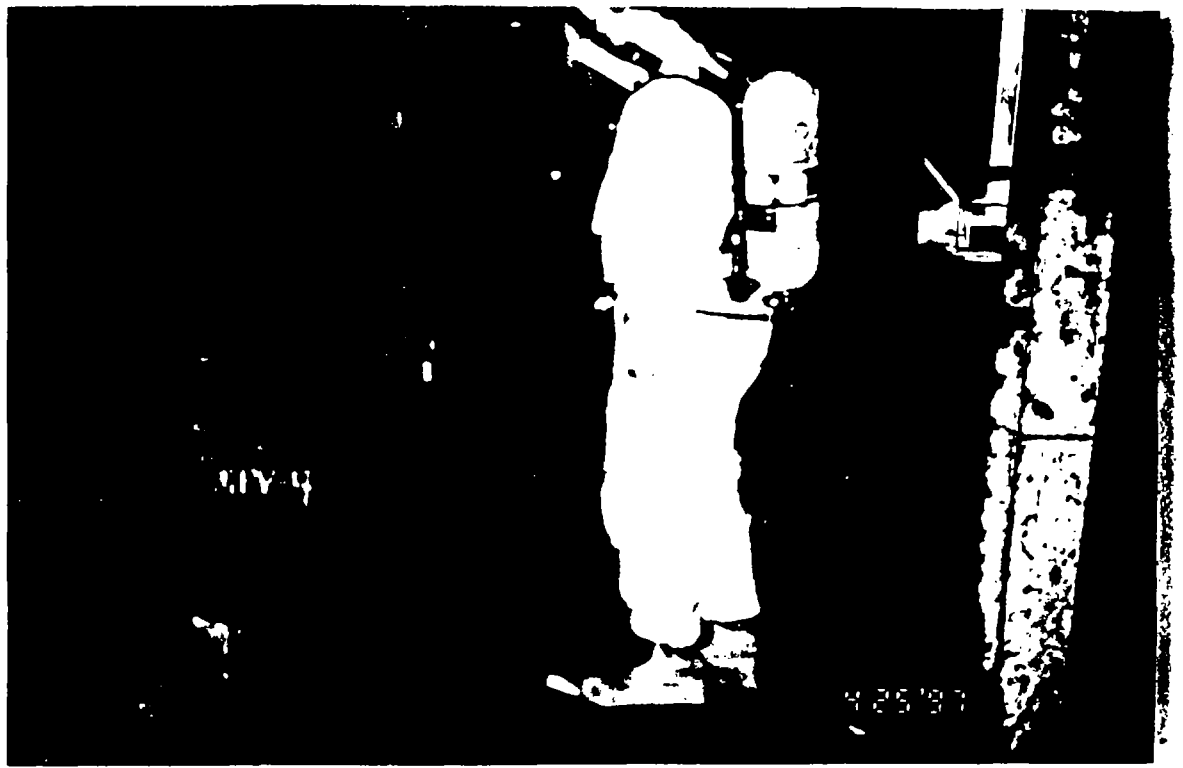
Site: Metro Plating
 Photo No: 9 (R1F1)
 Direction: East
 Camera: Olympus Infinity 35mm
 Photographer: E. Edlinger

Analytical results indicated that samples MPV3 and MPV9 had pH levels less than 1 standard unit. Sample MPD2 had a pH level greater than 12.5 standard units. Samples MPD2, MPD19, and MPV3 contained concentrations of TCLP chromium that exceeded the TCLP regulatory limit for this contaminant, with results between 38.1 milligrams per liter (mg/L) and 360,000 mg/L. Samples MPV3 and MPD19 contained concentrations of TCLP copper above the TCLP regulatory limit. Samples MPV3 and MPV7 contained concentrations of TCLP nickel above the naturally occurring soil concentration range of 5 to 500 parts per million (ppm). Sample MPD2 contained levels of TCLP zinc and lead exceeding the TCLP regulatory limits.

Date: April 25, 1997
 Subject: START member collects
 sample MPV3.

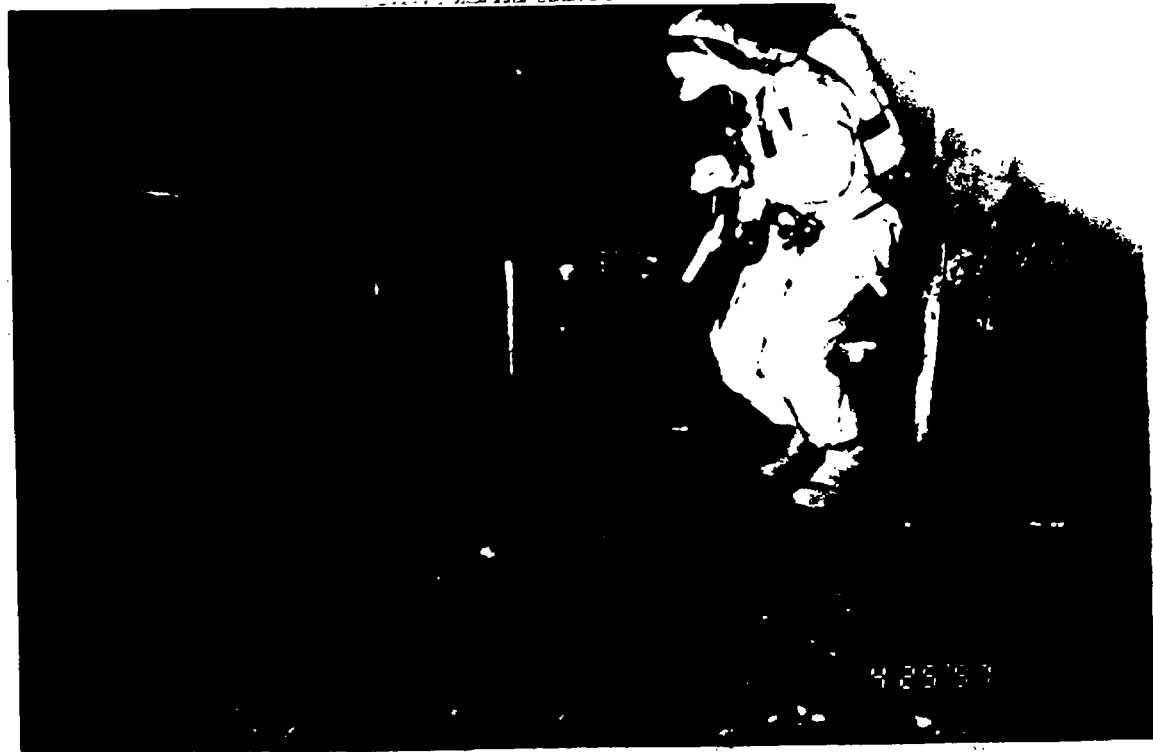
Site: Metro Plating
 Photo No: 10 (R1F2)
 Direction: East
 Camera: Olympus Infinity 35mm
 Photographer: E. Edlinger

Date: April 25, 1997
 Subject: START member collects
 sample MPV7.

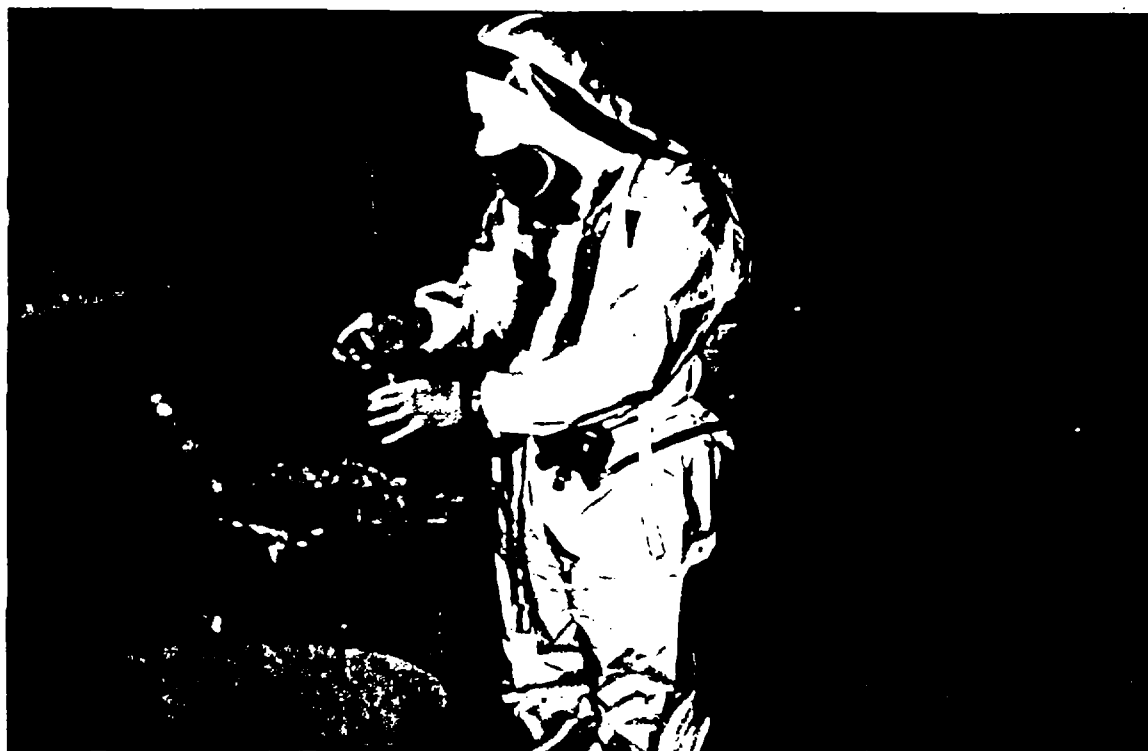
Site: Metro Plating
Photo No: 12 (R1F4)
Direction: Northeast
Camera: Olympus Infinity 35mm
Photographer: E. Edlinger

Date: April 25, 1997
Subject: START member collects
sample MPD2.

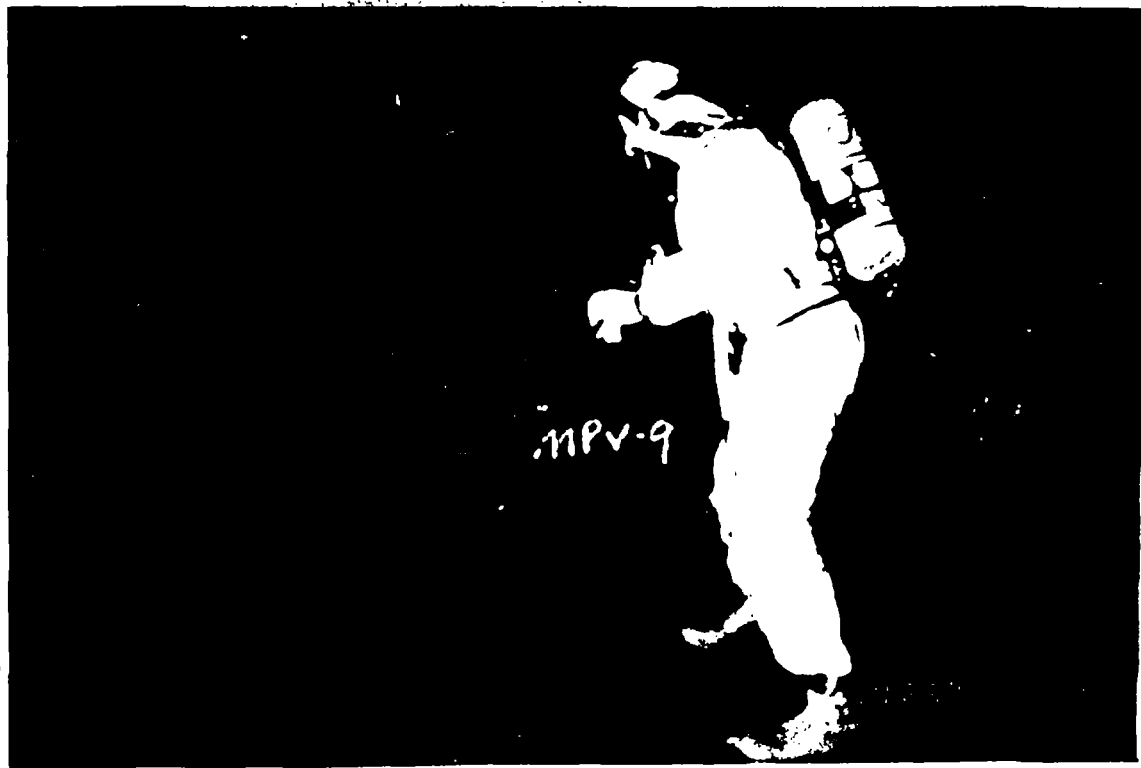
Site: Metro Plating
Photo No: 13 (R1F5)
Direction: East
Camera: Olympus Infinity 35mm
Photographer: E. Edlinger

Vat 9, from which sample MPV9 was collected, is surrounded by fluid with a pH between 10 and 11. The corrosive nature of the liquid makes the breakdown of Vat 9 likely, which would result in a violent reaction when the acid in Vat 9 and the base in the pit mix.

Date: April 25, 1997
Subject: START member collects sample MPV9.

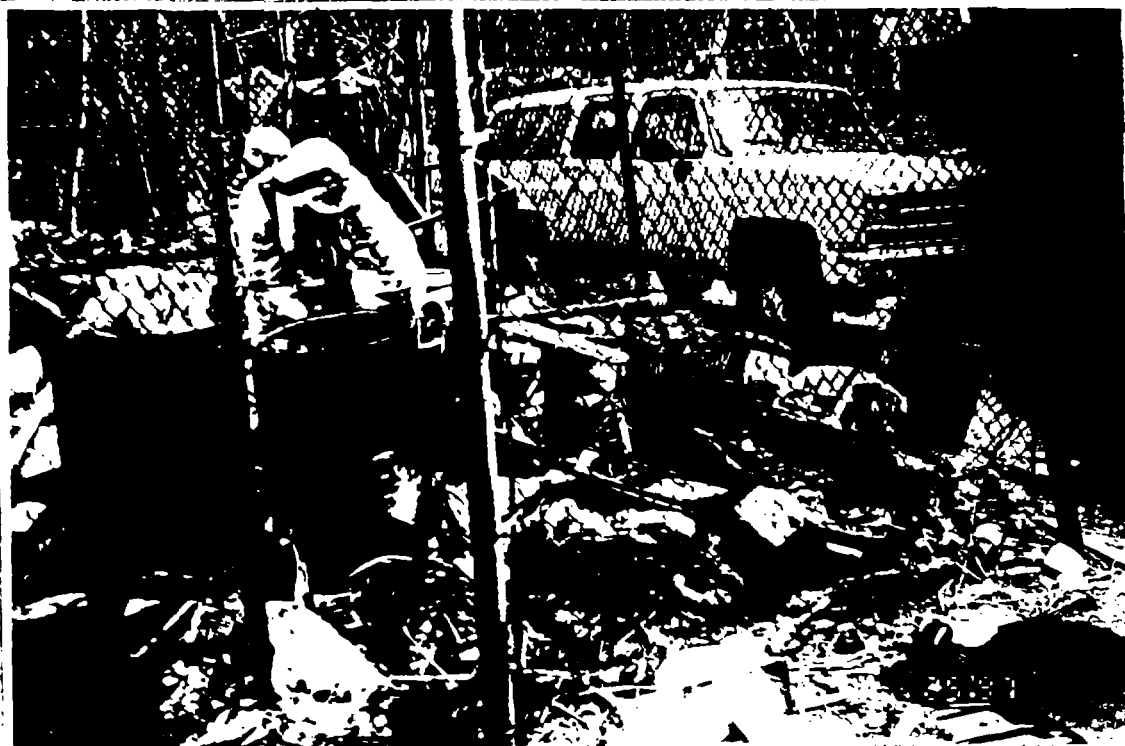
Site: Metro Plating
Photo No: 14 (R1F6)
Direction: Southeast
Camera: Olympus Infinity 35mm
Photographer: E. Edlinger

Date: April 25, 1997
Subject: START member collects sample MPD19.

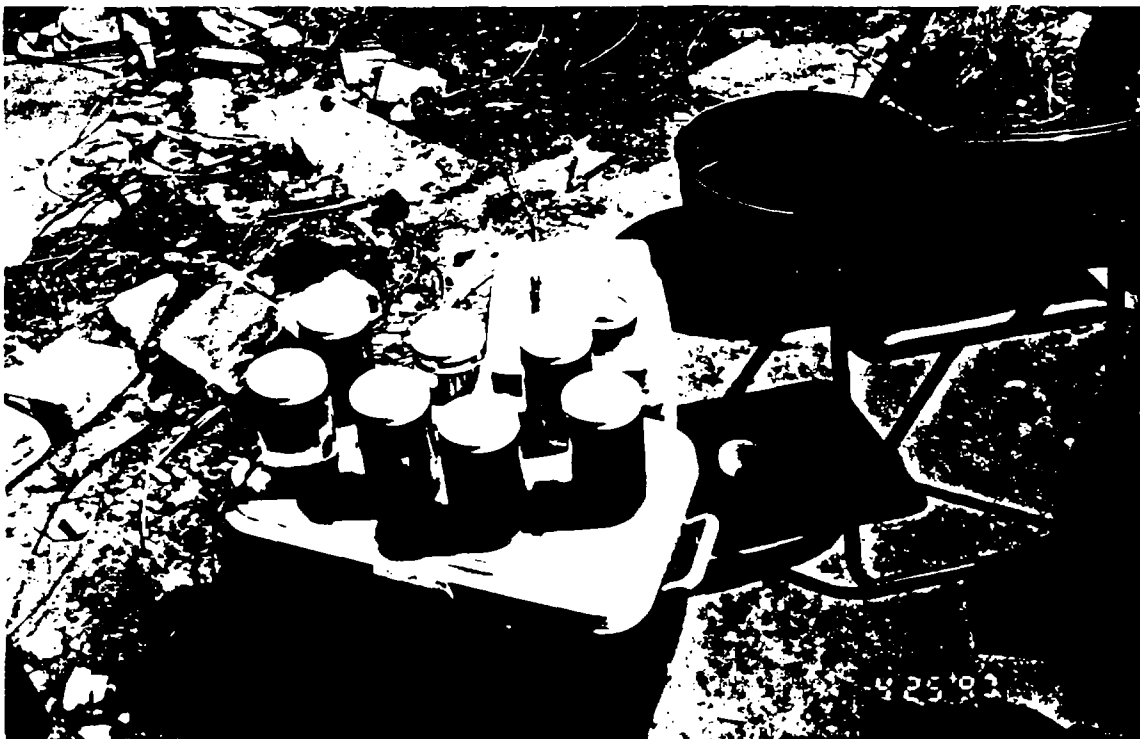
Site: Metro Plating
 Photo No: 16 (R1F10)
 Direction: Southeast
 Camera: Olympus Infinity 35mm
 Photographer: E. Edlinger

Date: April 25, 1997
 Subject: Samples collected
 from Metro Plating.
